DØ Status and Operations

June 24 – July 1, 2002

SMT Water Leak Repair

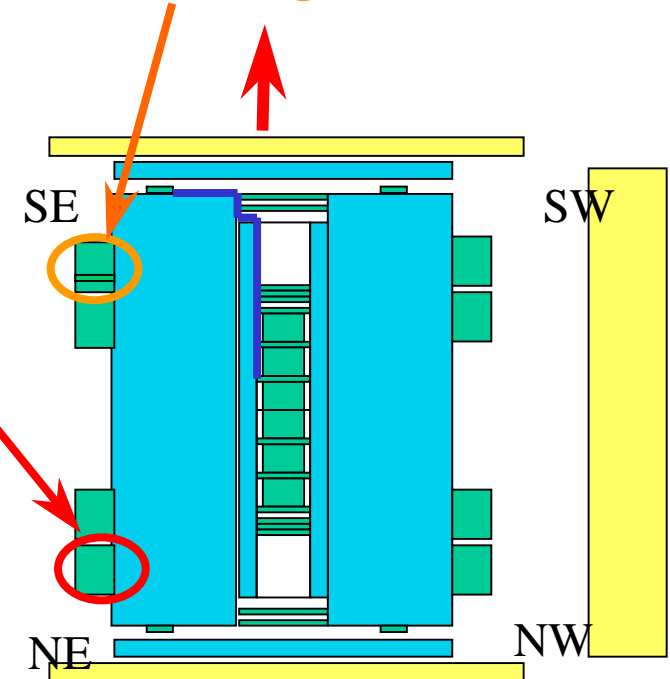
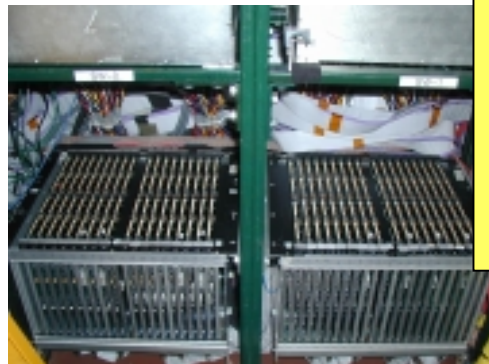
- Both crates running air cooled, about 10°C warmer than others
 - hottest spot ~ 35°C

Heat Exchanger disabled 4/11

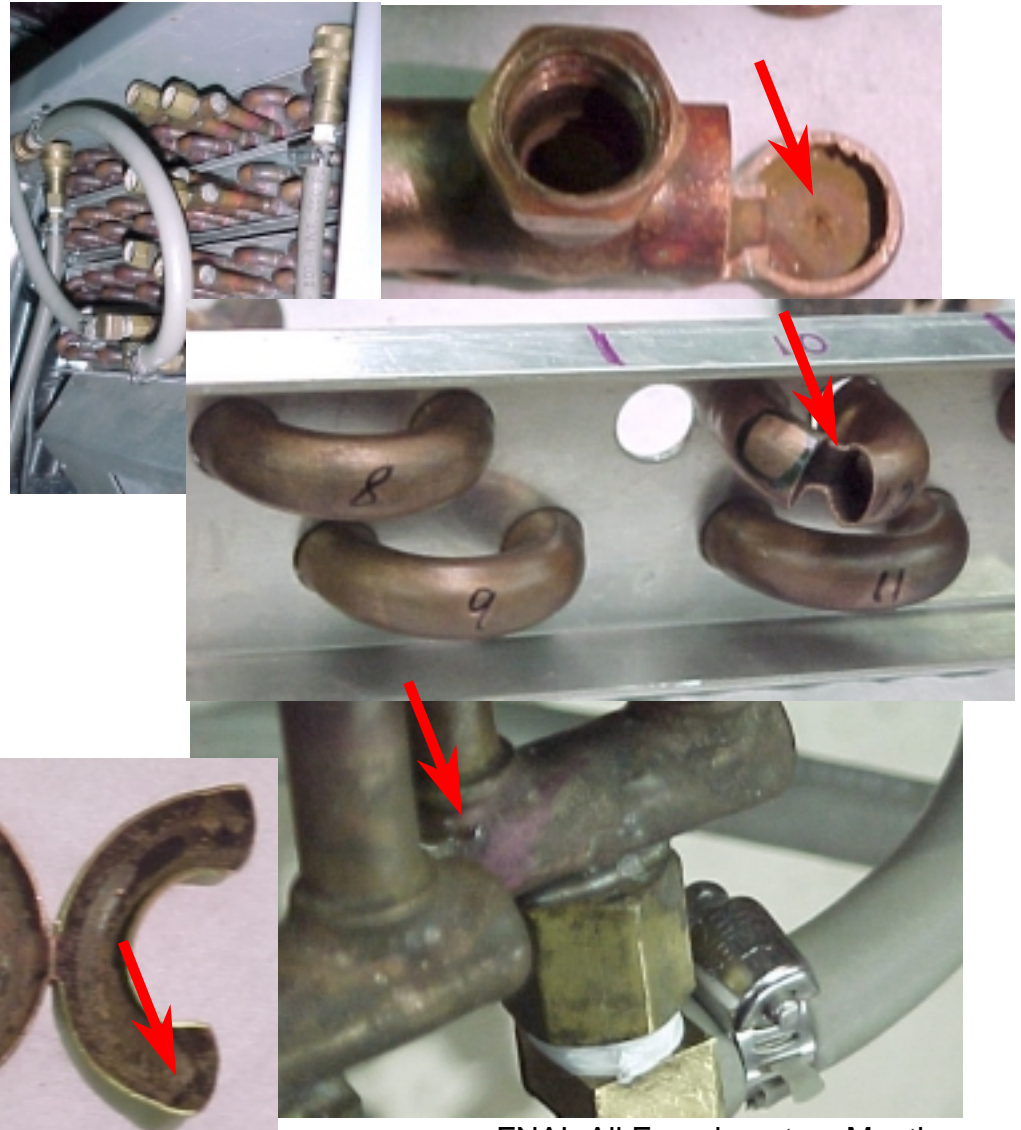
- Most common leak point in the end caps of the main supply or return tee
 - ♦ Indentation or dimple weak point
 - ♦ End caps soldered in Run 1 HXs
- Next most common Tee-solder branch
 - ♦ small crack-like leak develops at the side of the attachment tee (stressed?)
- Small rate of pin-hole leaks developing in the U-bend tubes
 - ♦ No significant signs of erosion seen (thickness about 15-19 mils). Believed to be sweat fitting that fails
- Using DCW
 - ♦ pH 7.8-8.0, chlorine < 0.5ppm, alkalines < 35 ppm
- Summary: slow gradual wear and tear. Can mitigate some of the risk before October if have access
